Restoration of Tektronix 564 Storage Oscilloscope

Version 1.0
May 7, 2019

M.T. Konstapel

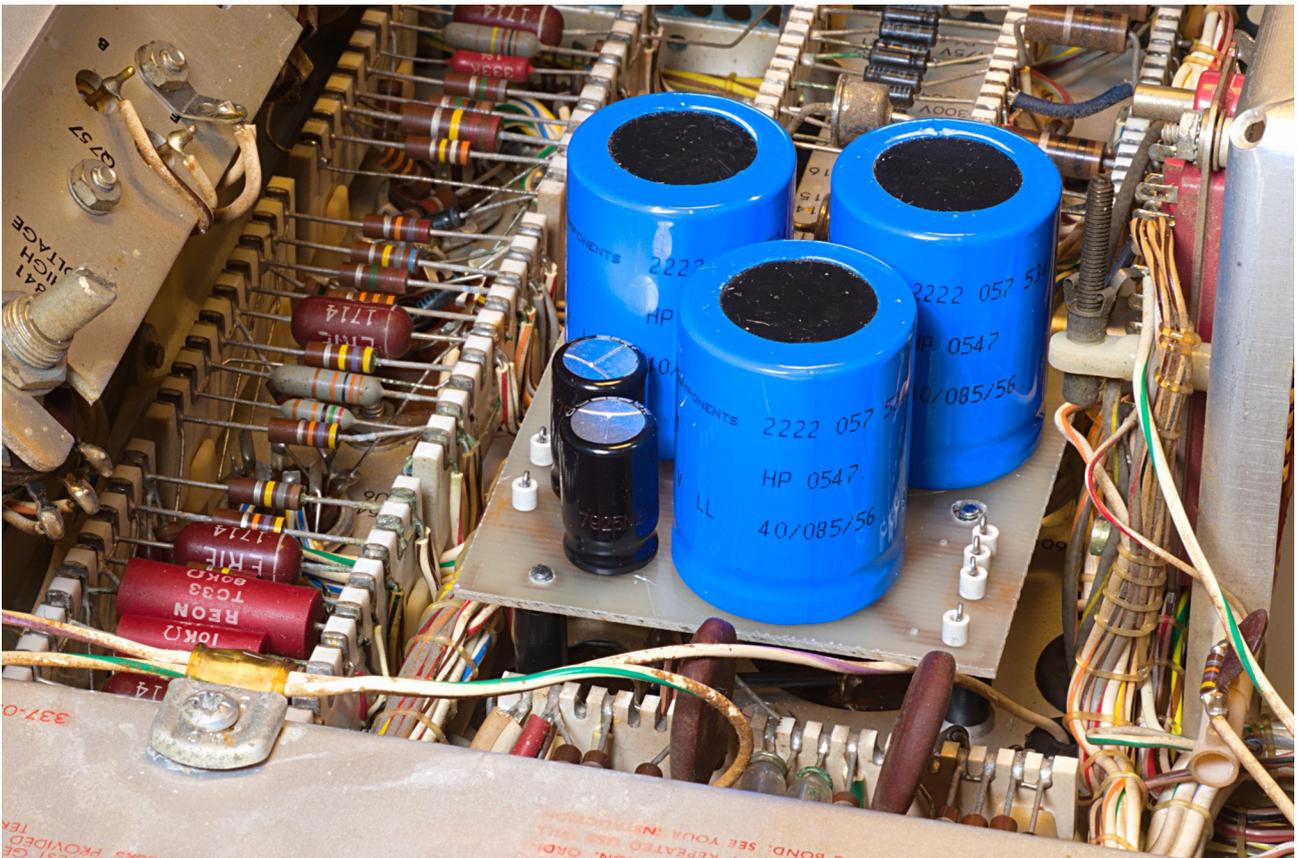
Image 1: First PCB with main filter capacitors (not connected yet)

The main filter capacitors had to be replaced as well, but I wanted to keep these old capacitors in the main cabinet, as these are typical for this era. So, I designed two printed circuit boards which could be placed on the existing mounting screws of the old capacitors. The wires going to the old capacitors could now be unsoldered and solders to the new pcbs. This way, the old capacitors where still in the cabinet, but not electrically connected. A neat solution that could also be removed to restore the oscilloscope to its former original state.

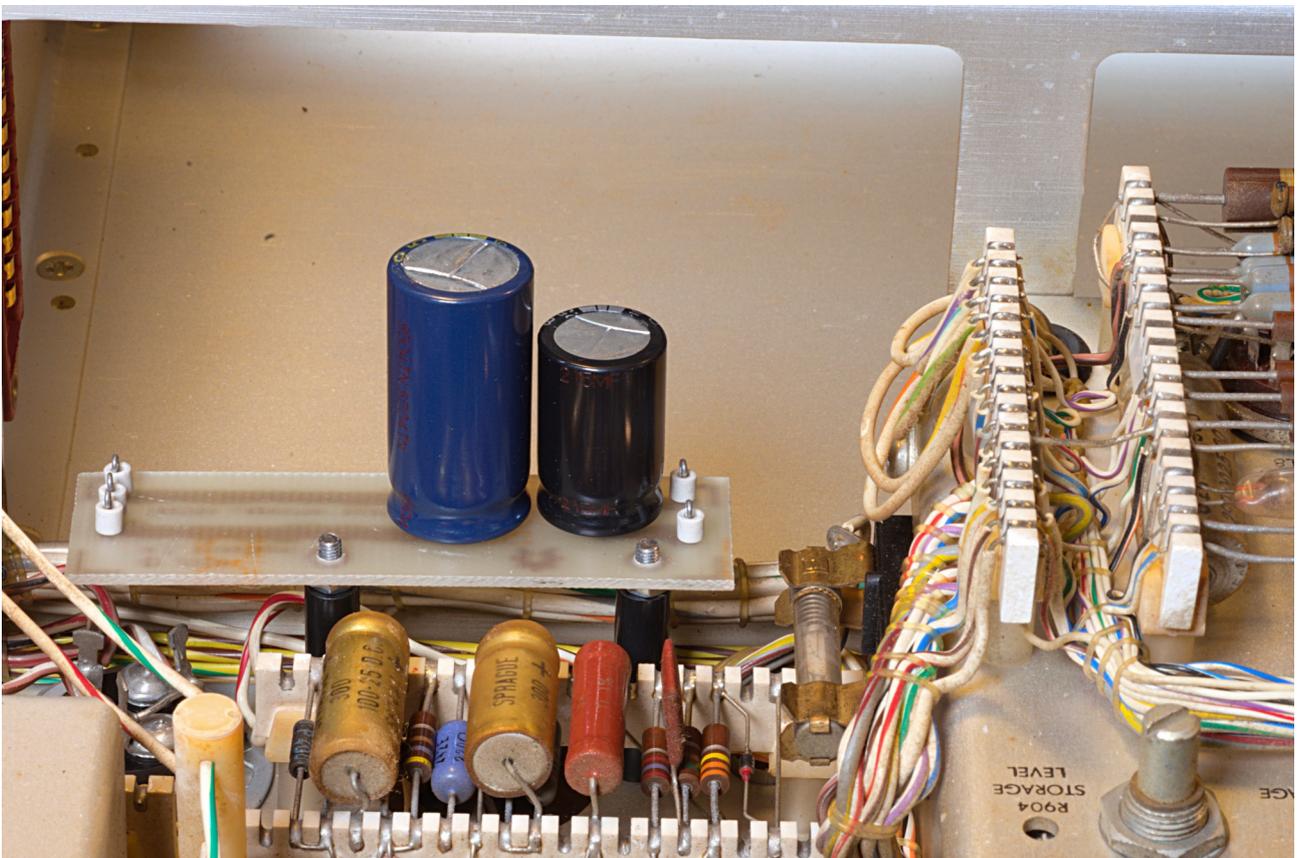
Image 2: Second PCB with main filter capacitors (not connected yet)

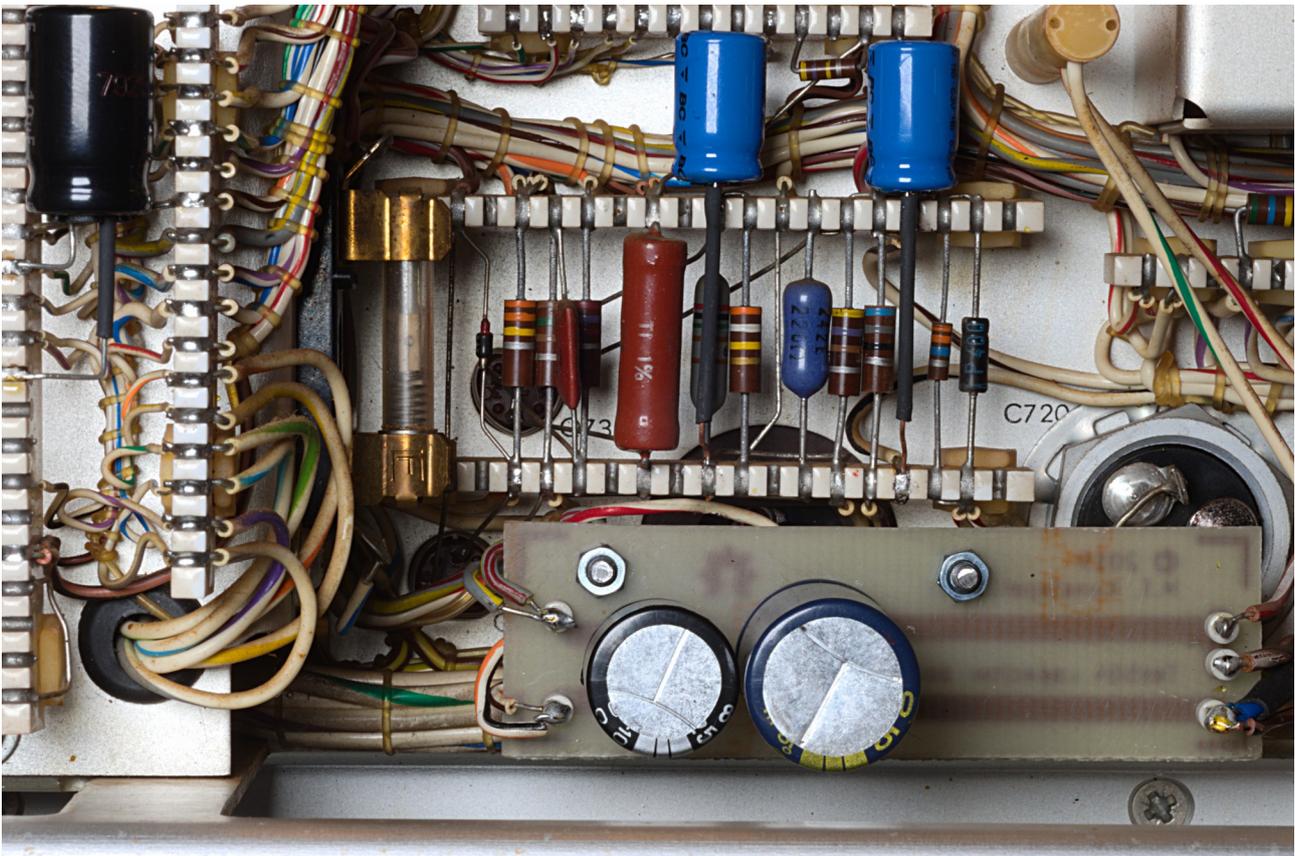
Image 3: C732 and C757 on ceramic strip (blue caps), also connected second PCB

The electrolytic capacitors on the ceramic strips were removed and replaced by new capacitors. I made sure I used solder with 4% silver. This is important as the ceramic strip is impregnated with silver in order to establish a mechanical bond with the ceramic. Using ordinary solder may loosen this mechanical bond.

In the main cabinet, I replaced capacitors C667, C667, C876, C904, C935, C732, C757. On the time base module (3B3), I replace capacitor C115 and on the vertical amplifier module (3A6), I replaced capacitor C453.

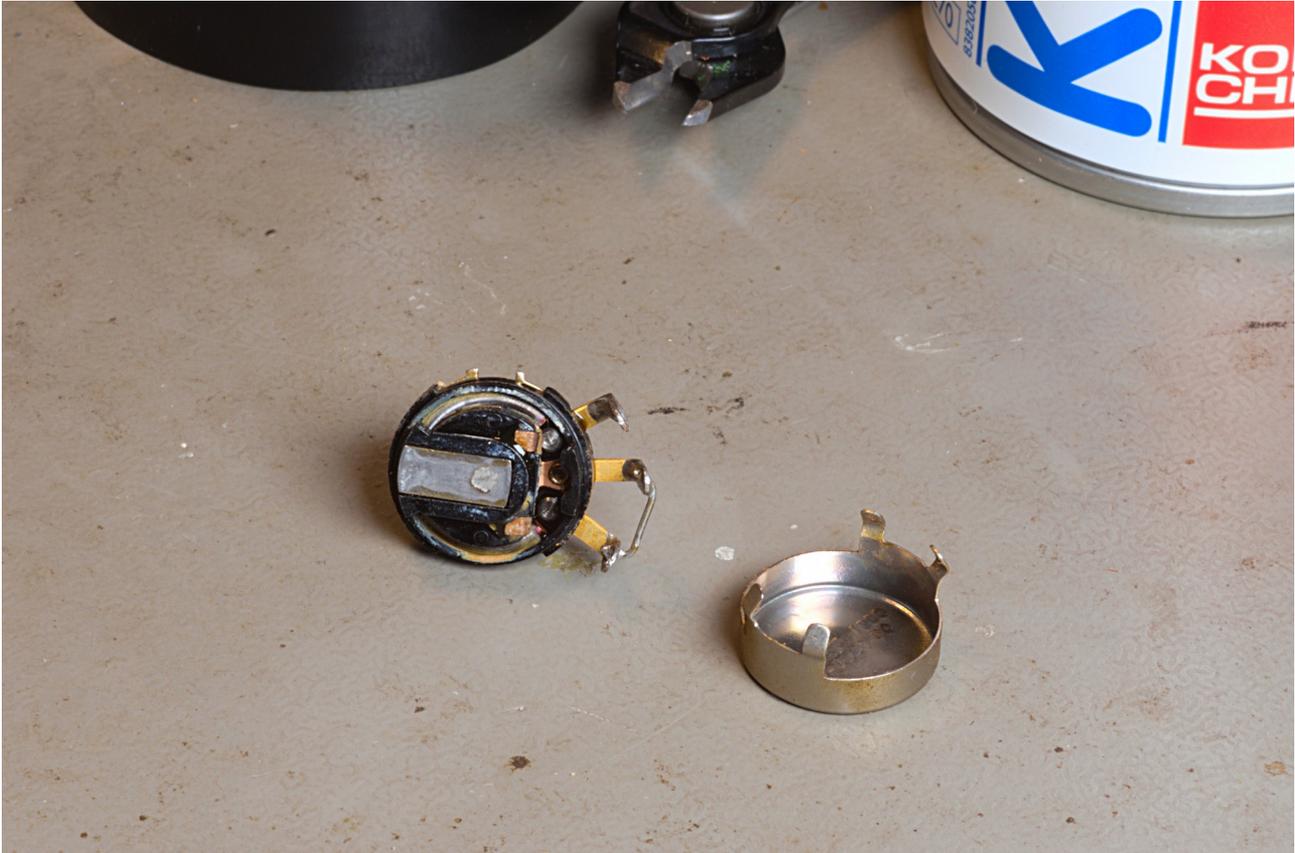
When I inserted the vertical amplifiers, the screen went blank. After a lot of trouble shooting, I found a defective potentiometer: the wiper did not made contact with the resistive material. I removed and disassembled it in order to clean it with some contact cleaner. This seemed to repair the potentiometer.

Image 4: Opening the potentiometer to clean it
